# River Morphology, Floods & Sediment – An Introduction

Mike Harvey, Ph.D.

Motueka Catchment Collective:

Living River: Ki Uta Ki Tai

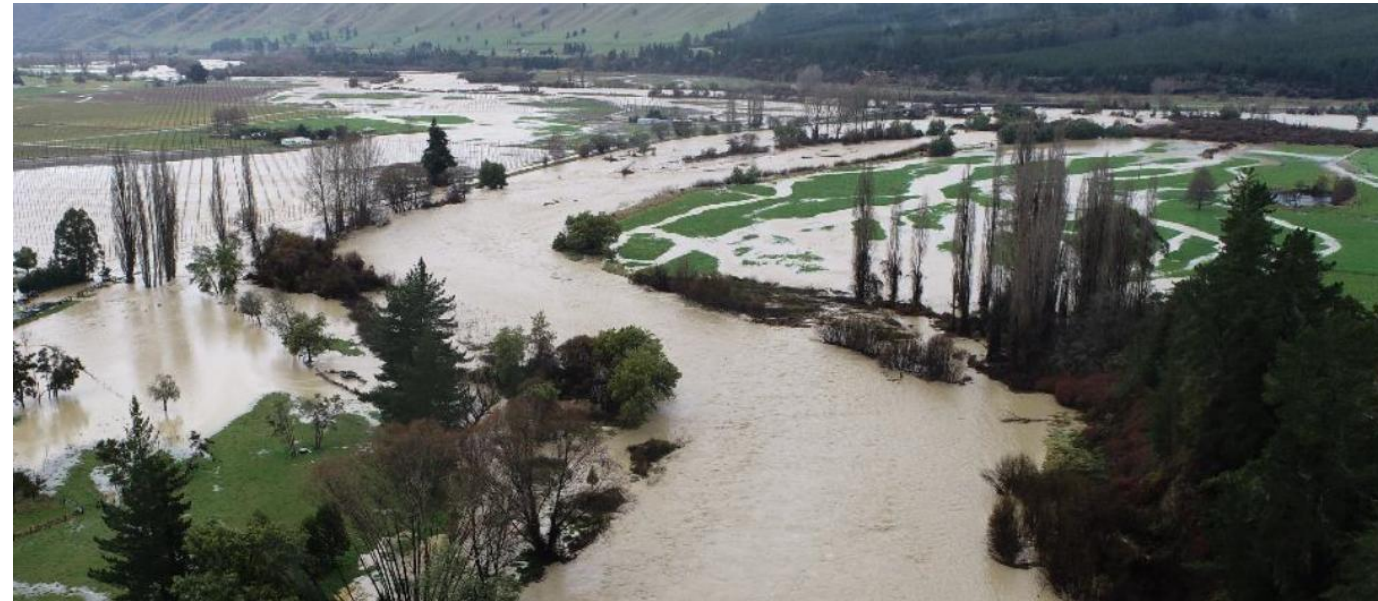
# Upper Motueka River; 100-yr (1% AEP) Flood Depths; We Have Modelling Tools to Predict Flood RISK

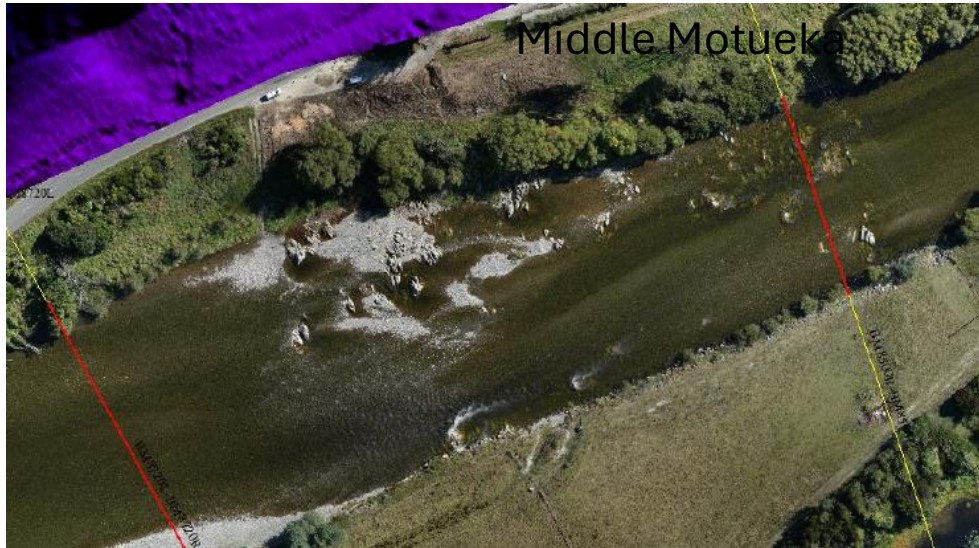
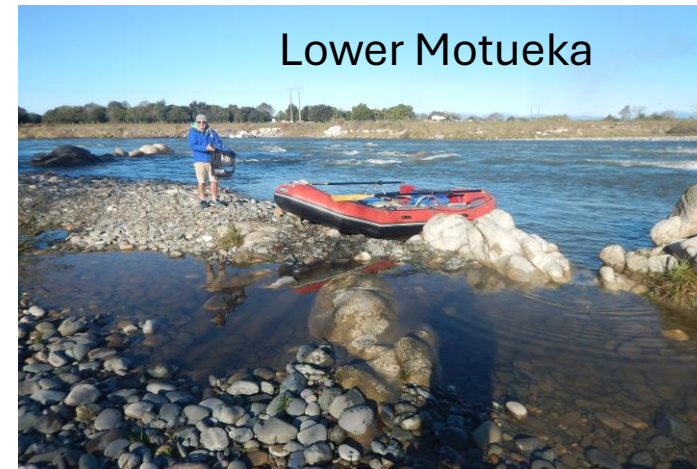
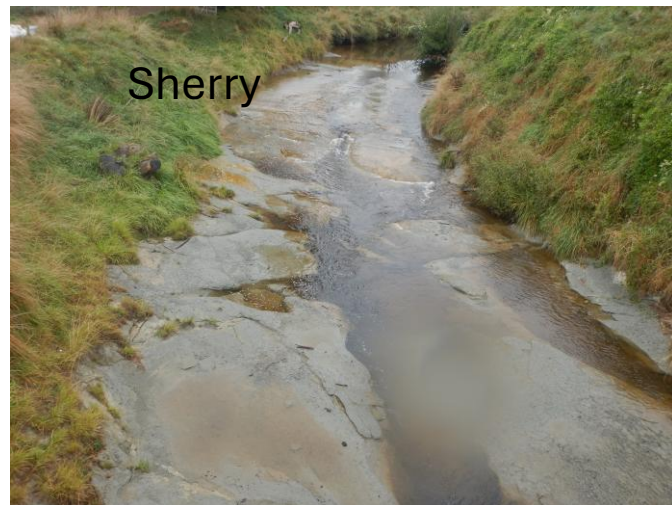
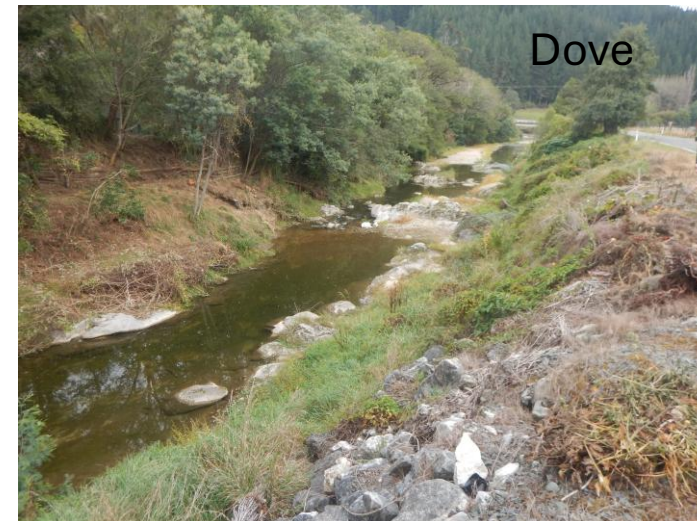
# Bedrock Controls: What do they tell us about sediment supply?

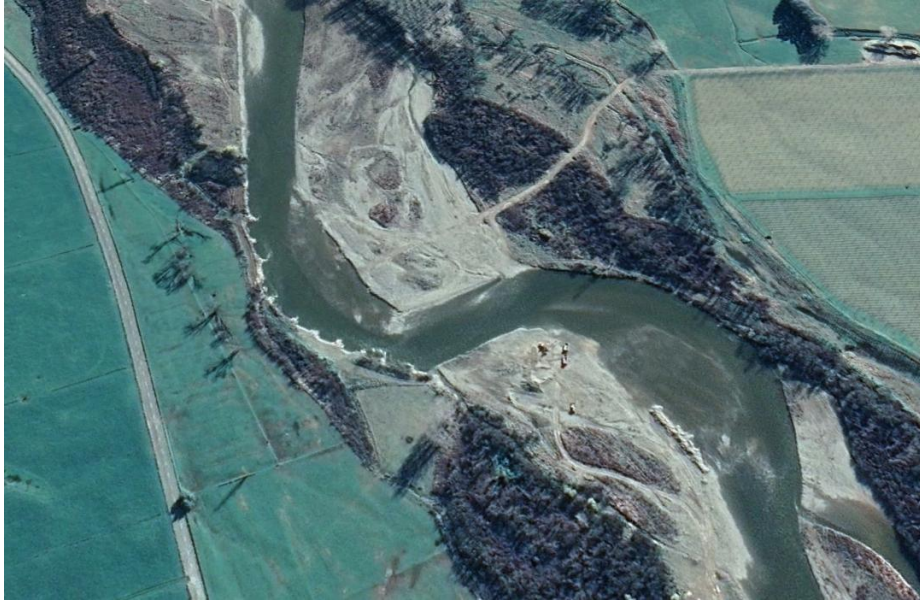
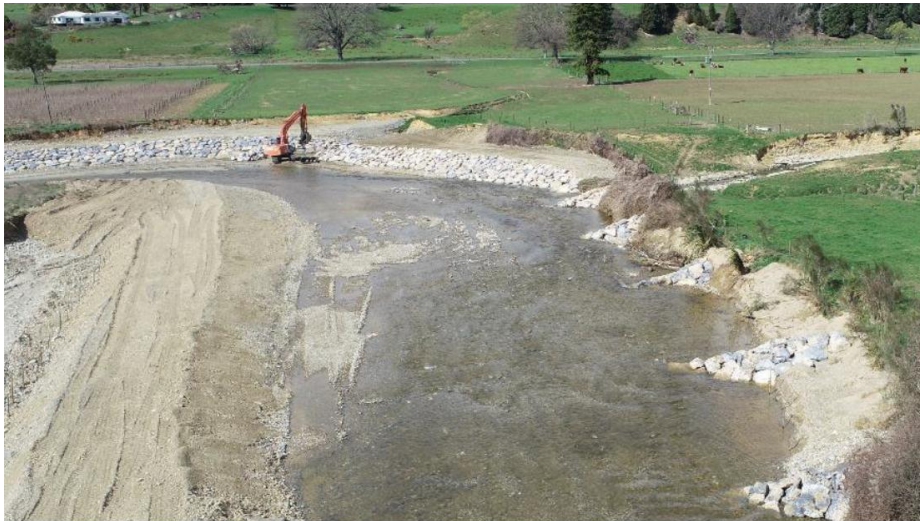
# SAND AND GRAVEL EXTRACTION FOR FLOOD CONTROL

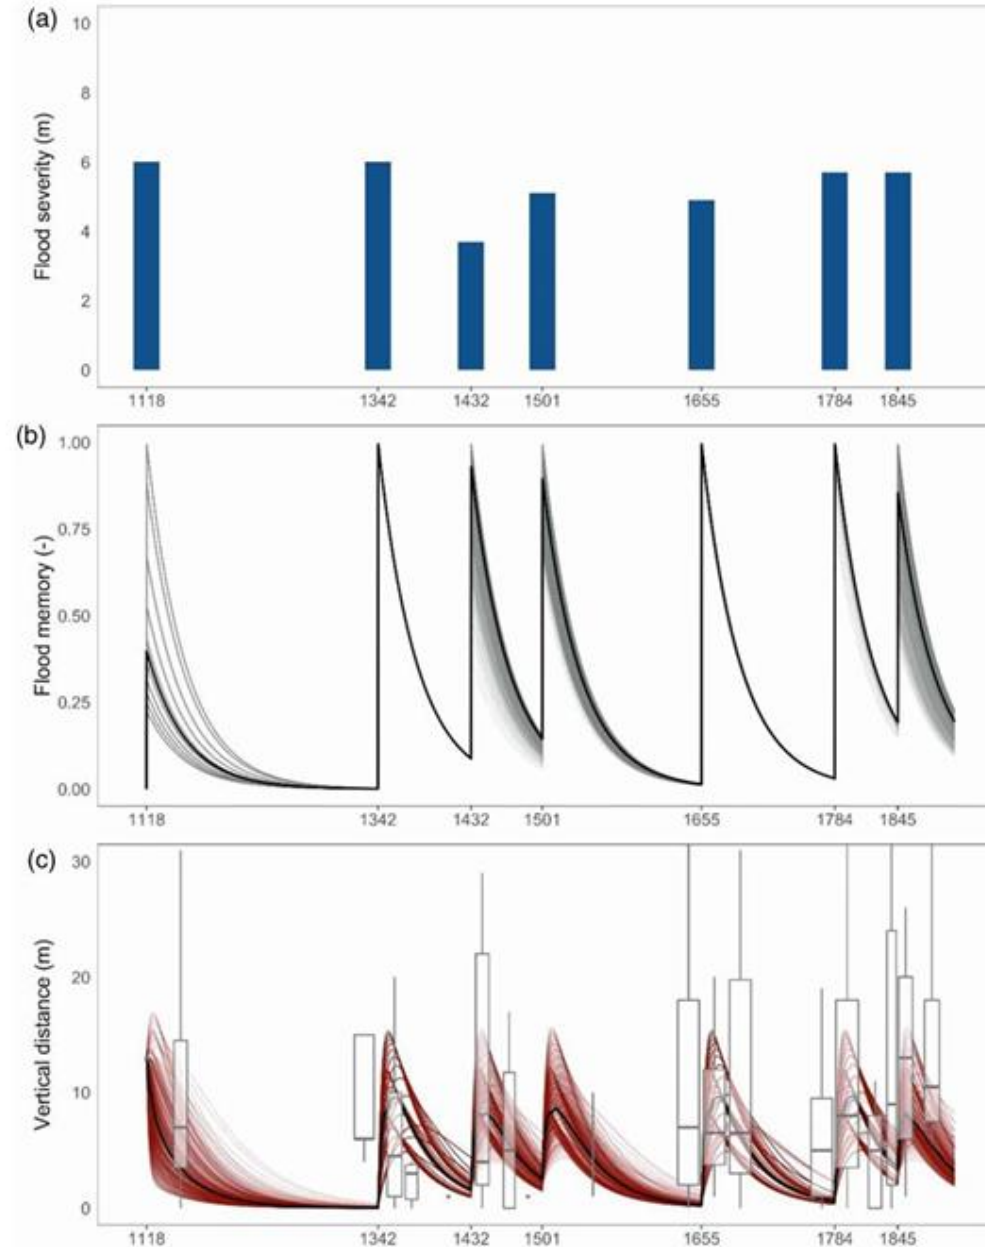
# POST-FLOOD COLLECTIVE MEMORY:

Vltava River, Czech  
Republic  
(Ridolfi et al, 2021)

7 Large Floods in ~ 700 yrs
