LIVING FENCES AND IMPROVED FORESTRY PRACTICES FOR WOODY DEBRIS MANAGEMENT

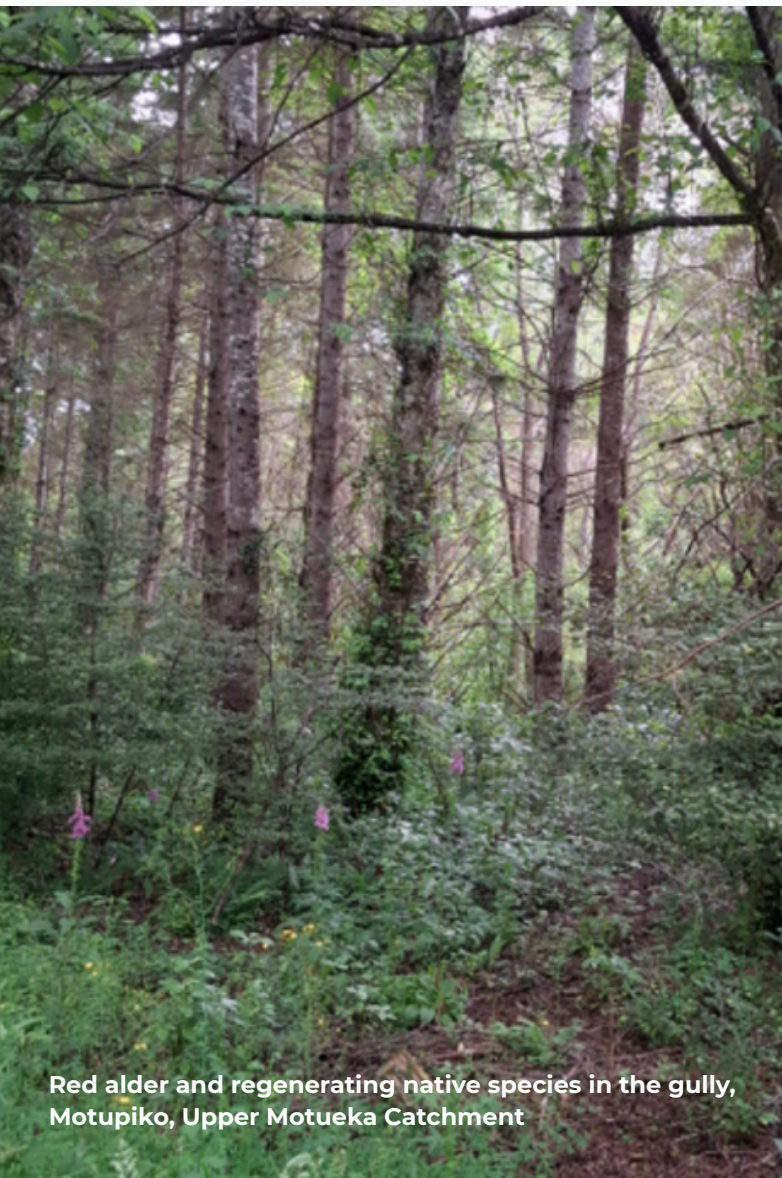
Red alder and regenerating native species in the gully, Motupiko, Upper Motueka Catchment

An adjacent block with lower erosion risk was later purchased. A stream on this property flowed toward a downstream dairy farm. To protect riparian margins, plantings of poplar, red alder, and Douglas fir were established along stream edges. Trenches were created using a ripper, and planting occurred at a density of approximately 1,100 stems per hectare, generating sufficient shade to suppress weeds. Over time, Douglas fir and red alder have become self-replacing, with native species regenerating naturally beneath them. Selected trees have been pruned to improve form and allow for potential future timber harvest.

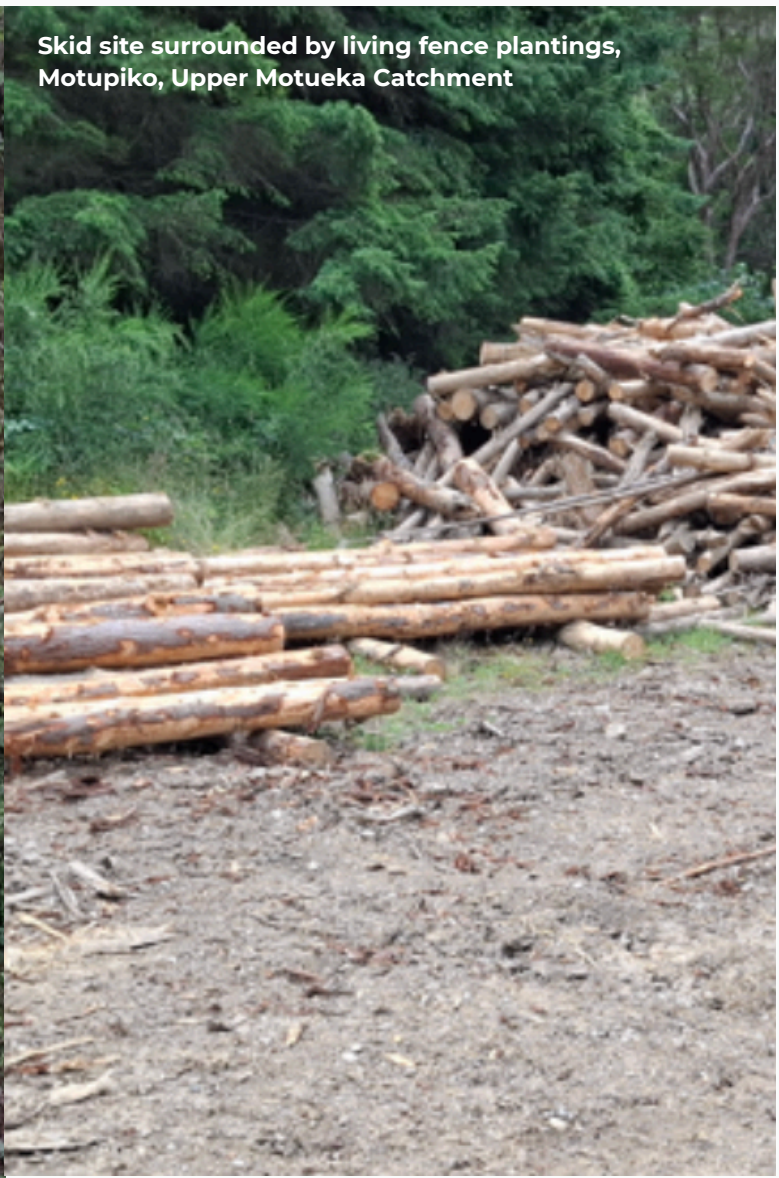
Skid site surrounded by living fence plantings, Motupiko, Upper Motueka Catchment

A regional shortage of logging equipment, resulting from an estimated 10,000 hectares of windthrow across the district, required a tailored recovery approach. Timber was salvaged using a small crew and a bulldozer. The presence of living fences provided a strategic advantage by allowing the skid site to be located among alder trees just outside the riparian margin. This placement reduced slash movement and improved the efficiency of the harvest operation. The effectiveness of sediment control measures was confirmed by downstream silt capture ponds, which showed no visible discolouration.

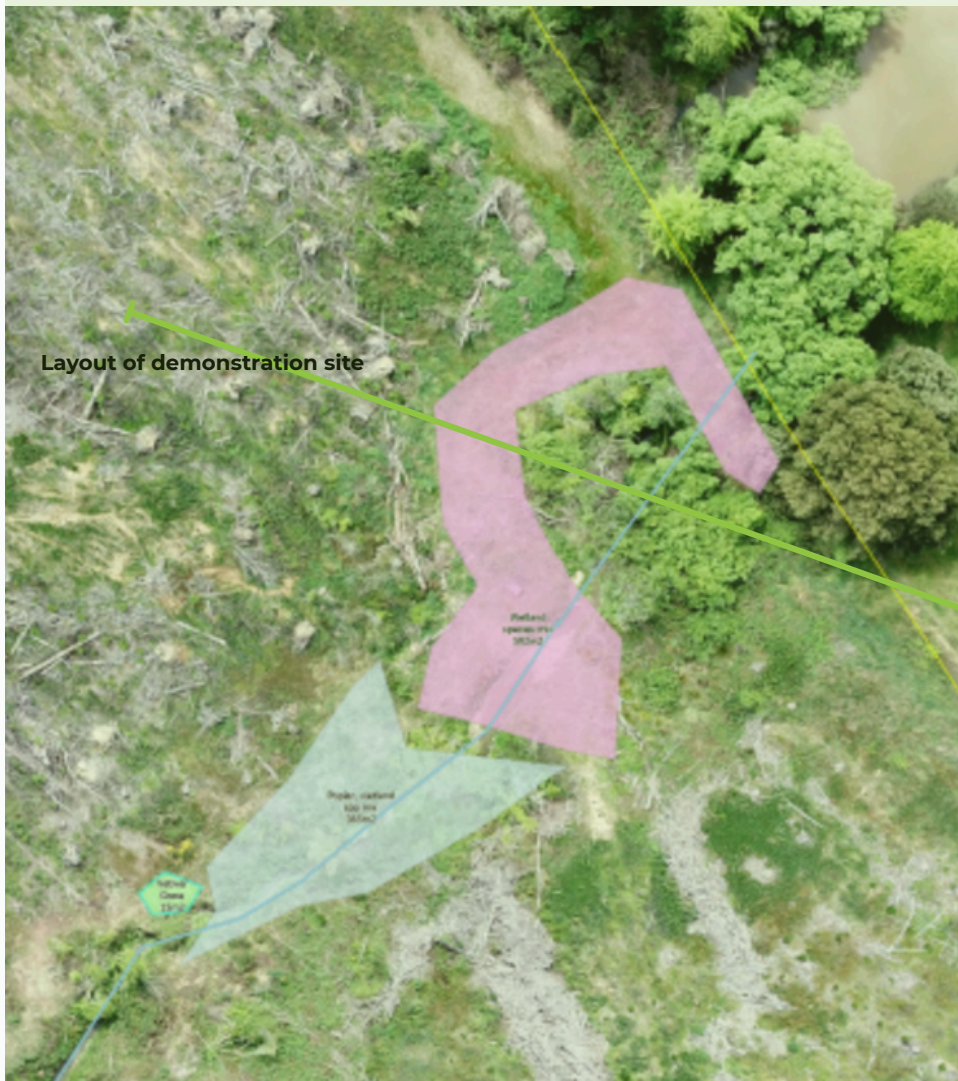
Wetland area prior to planting

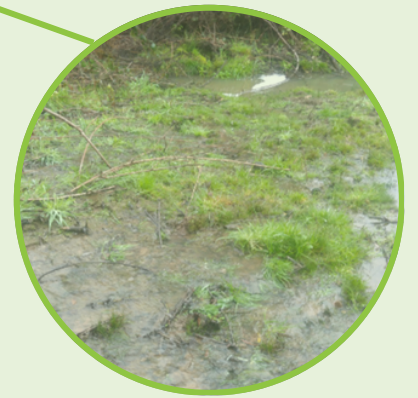
January 2026 drone footage of Arrow Living fence, Moutere Catchment

- Three arrow-shaped living fences, each approximately 75 metres long, established using 1-metre rooted cuttings of Crowsfoot poplar (supplied by Appletons Nursery)
- Plant spacing of 1.5–2 metres
- A naturally flat engaged flood plain area approximately 30 metres downstream, enhanced with 1,000 wetland plants (including *Carex secta*, *Carex virgata*, swamp flax, giant rush, bullrush, jointed baumea, and vetiver grass) to capture fine sediment

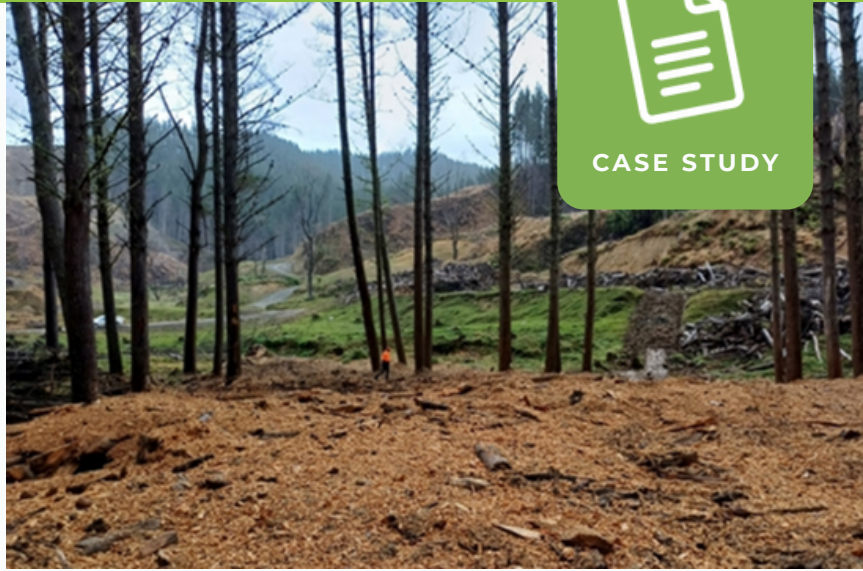
Picture to the right, a living fence of unharvested pine trees in Gisborne has captured significant woody debris. This debris was later mulched using an adapted head on existing forestry harvesting equipment. In the green area, poplar poles have been planted to contain debris in future events.

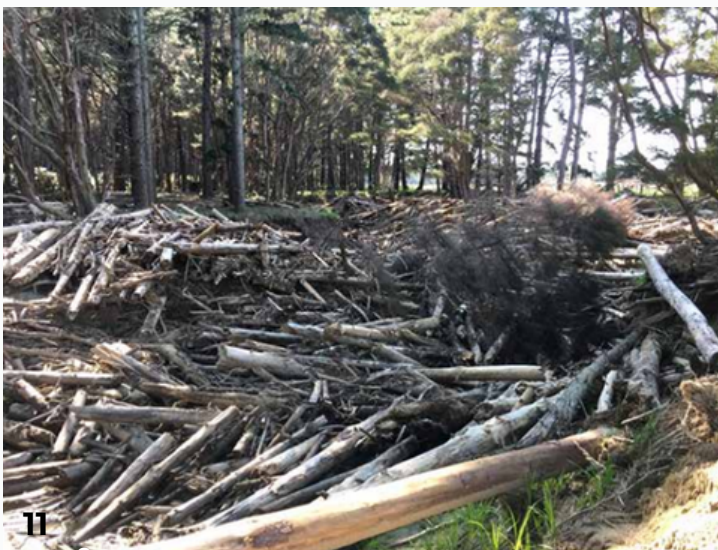
Pine left as a "hold" or living hold fence in Gisborne showing how effective it can be in capturing large woody material.

Interestingly, setbacks from waterways and the slow regeneration of native vegetation can unintentionally leave these areas more vulnerable. To address this, Fraser has implemented an innovative practice known as "hold living fences." This involves leaving unharvested pine trees standing along sensitive waterways during harvest. These trees remain in place until the entire catchment has been replanted, and the new trees have grown to a size that reduces the risk of mass movement. This method has already demonstrated its effectiveness, capturing approximately 20,000 tonnes of woody debris during a single storm event (see photo below). By consolidating debris in accessible areas, this practice also enables further solutions, such as mulching.

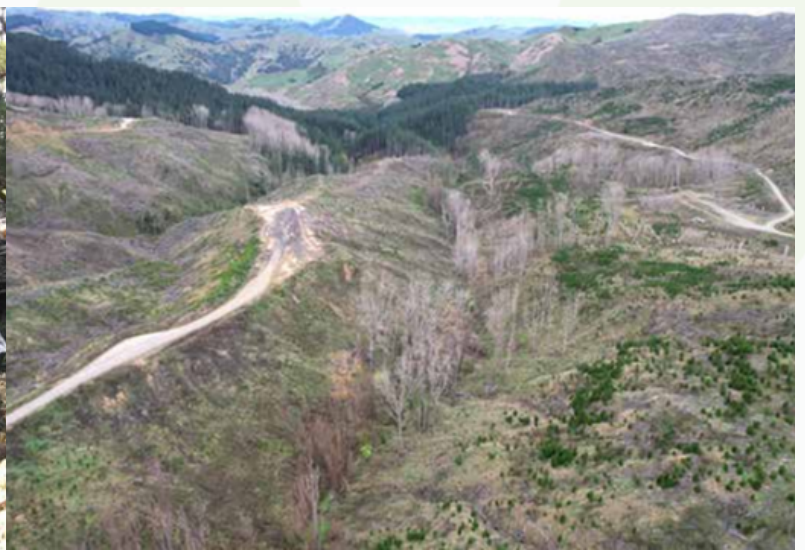
Living block fence of mature mixed poplars and willows along water ways offering full protection in lower part of the catchment in Gisborne.

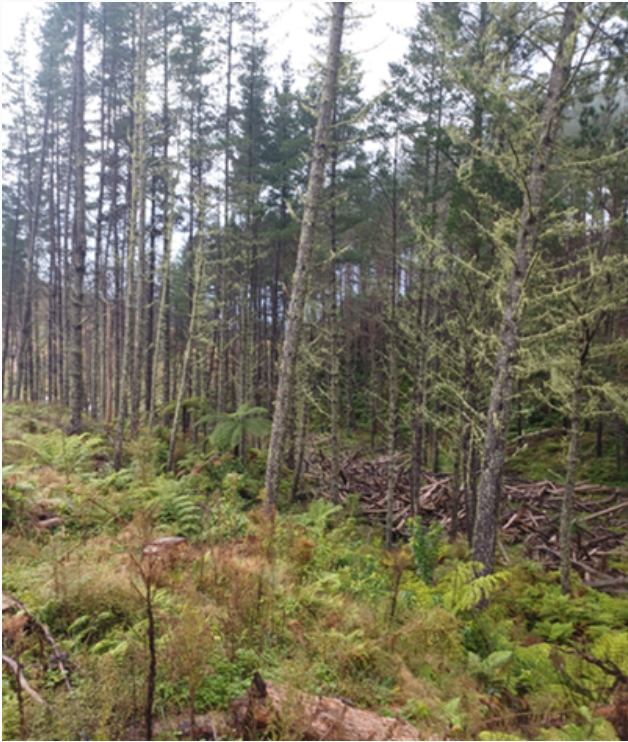
Hold trees that retained approximately 20,000 tons of large woody debris in Gisborne.

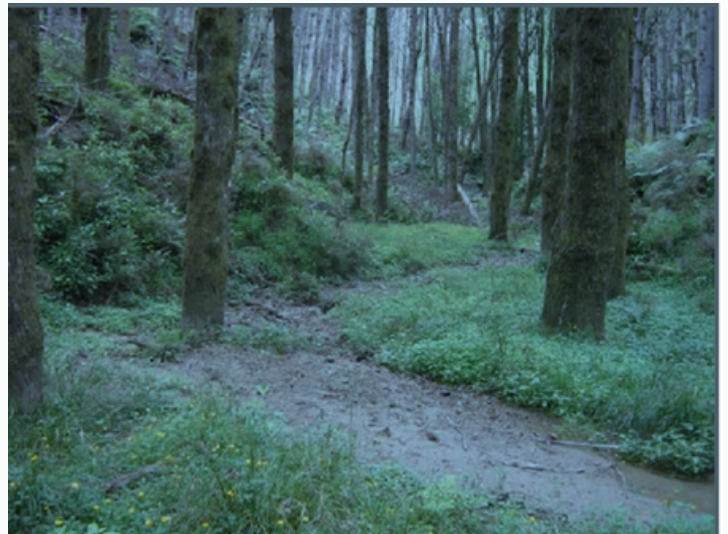
An example of a living block fence in Gisborne
